## PROPERTY CONDITION ASSESSMENT

# Condition Assessment & Indicative Value Range

The risk and value picture before you commit · Block 36, Lot 16, Frontiera Subdivision, Camella Gran Europa, Brgy. Lumbia, Cagayan de Oro City

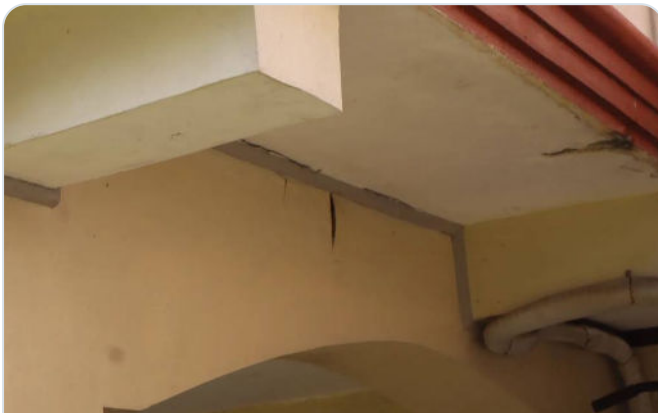
#### **PHOTO 1 · CRACK AND WATER STAINING**

**MODERATE****Water damage and ceiling stains** Photos 1–3**FINDING**

Stains, bubbling paint, and discoloration on ceilings of both floors, pointing to past or ongoing leaks around roof valleys and eaves.

**MODERATE****Wall cracks** Photo 1**FINDING**

Hairline to moderate cracks in interior and exterior finishes. Most appear to be cosmetic settlement cracks.

Crack at the wall-and-beam junction with water staining at the eave edge. To be verified by a structural engineer.

Fix the roof first, then repair and repaint ceiling finishes.

Structural engineer to verify larger cracks, especially near load-bearing beams or arches.

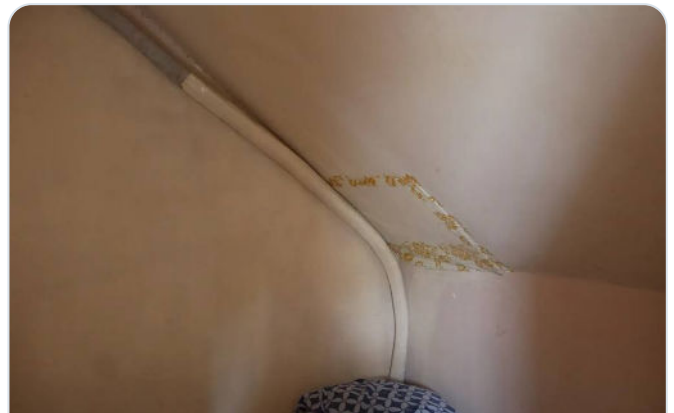
#### **PHOTO 2 · PATCHED CEILING STAIN**

Ceiling-wall corner: a patched stain covered with plastic sheet, consistent with past or ongoing leaks.

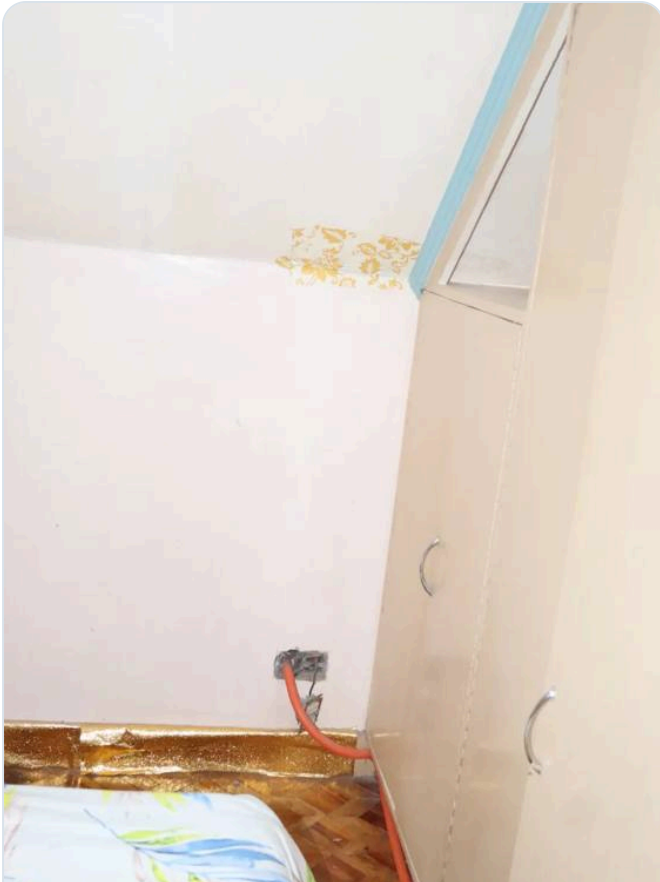
**PHOTO 3 · CEILING CORNER STAIN**

Stain at the ceiling corner near the window in a bedroom.

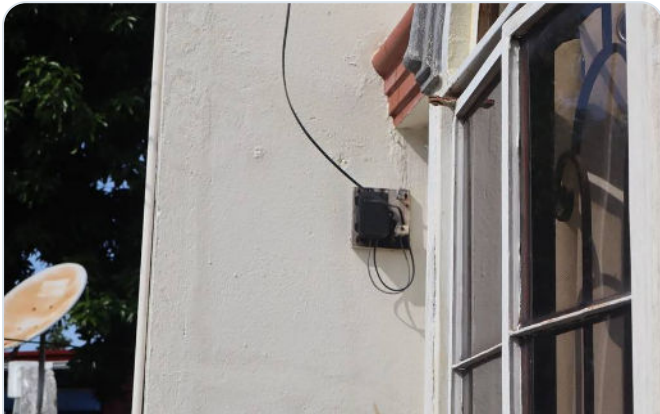
**PHOTO 4 · ELECTRICAL BOX**

**URGENT****Electrical service entrance** Photos 4–6**FINDING**

Service drop, meter base, and wiring appear inconsistent with Philippine Electrical Code requirements: exposed wires and a poorly secured entrance. This is a shock, fire, and outage risk.

Exposed electrical box and loose cable on the exterior wall. To be verified by a licensed Registered Master Electrician.

Verification and correction by a licensed Registered Master Electrician (RME). Treat as a safety item, not a cosmetic one.

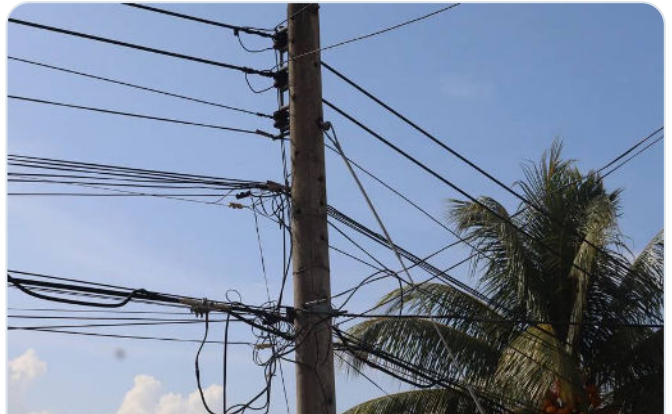
**PHOTO 5 · OVERHEAD LINES**

Overhead utility lines and pole near the property.

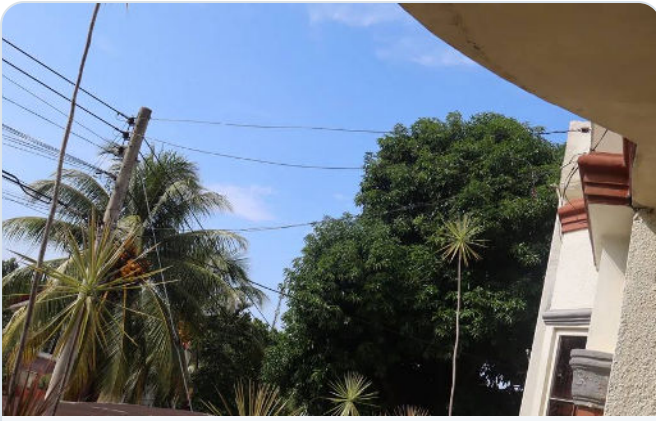
**PHOTO 6 · SERVICE LINES**

Overhead lines and pole beside the house.

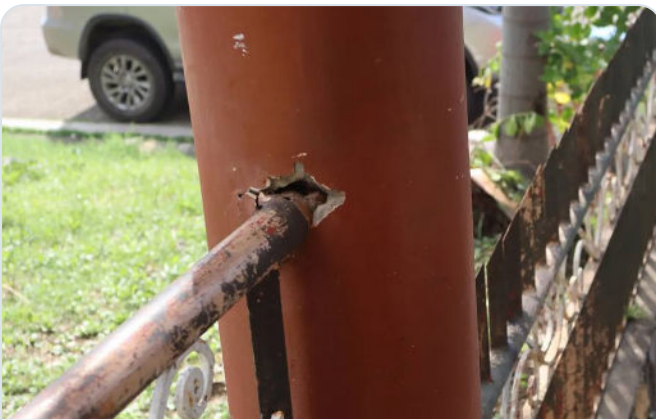
**PHOTO 7 · RAILING AND COLUMN**

Rusting railing anchored in a column, with spalled concrete at the connection.

Full repainting, done last.

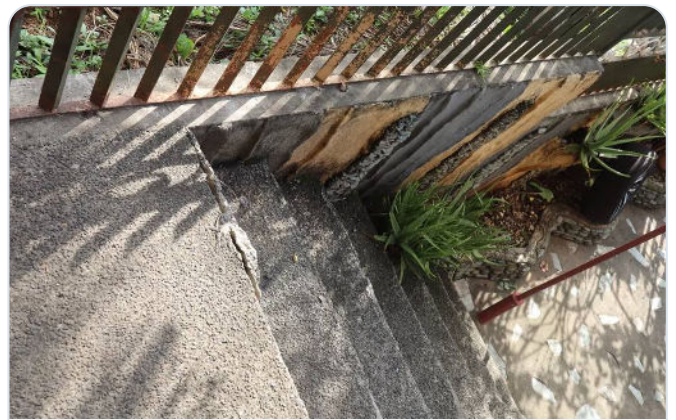
**PHOTO 8 · ENTRY STEPS**

Cracked entry steps and a rusting railing base.

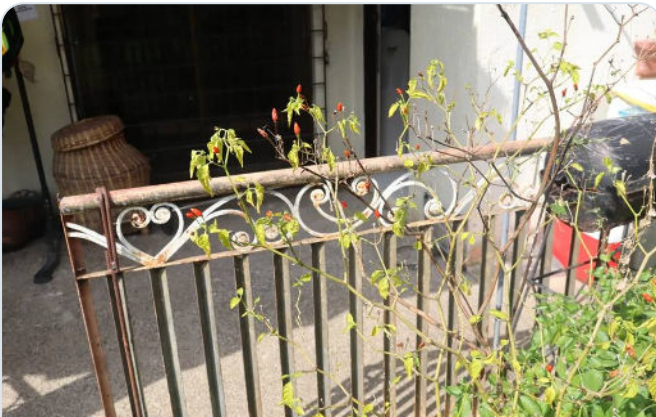
**PHOTO 9 · RAILING**

Wrought-iron railing with surface rust.

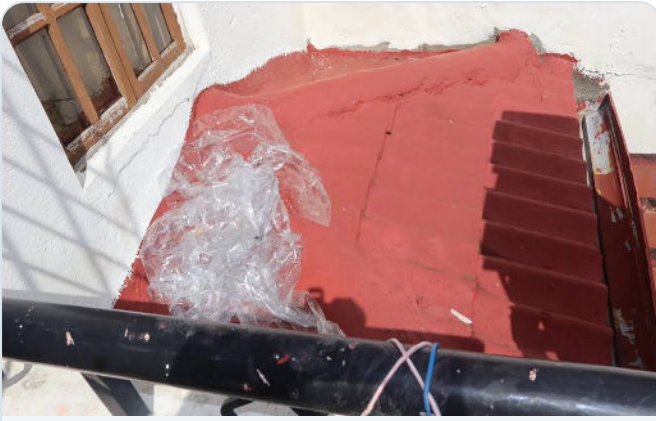
**PHOTO 11 · EXTERIOR STAIR**

Red-painted exterior stair and landing, with patched edges and cracking at the wall junction.

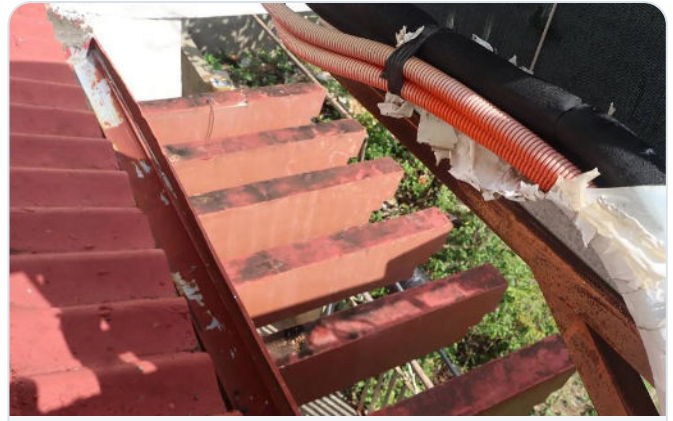
**PHOTO 12 · STAIR UNDERSIDE**

Exterior stair: peeling paint, rusting steel edge and taped conduit.

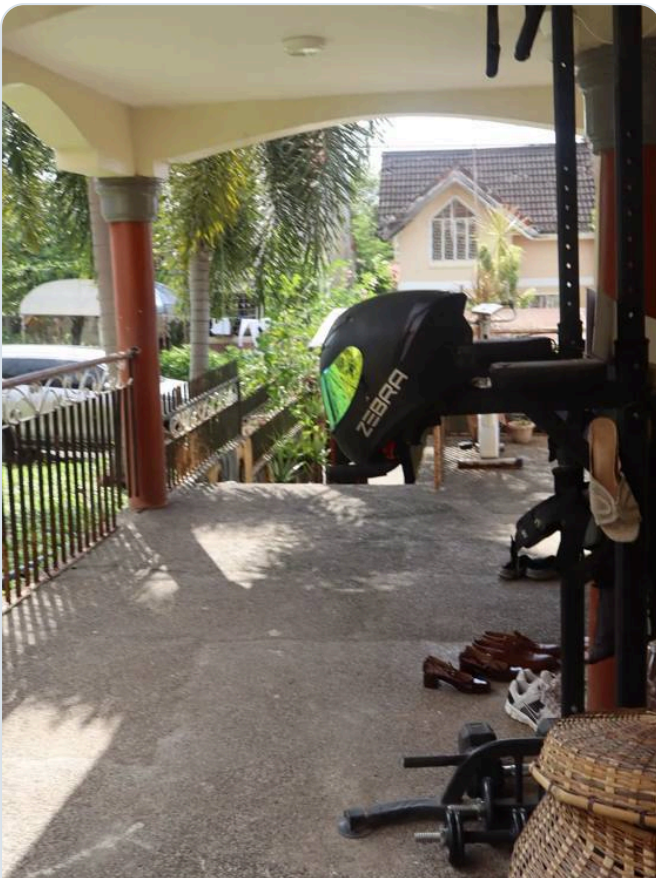
**PHOTO 13 · CARPORT AND PORCH**

Cluttered and weathered carport, laundry, and utility spaces; stained, aged polycarbonate carport roof.

Carport and porch, currently used for storage.

Clean and reorganize; consider new roofing material.

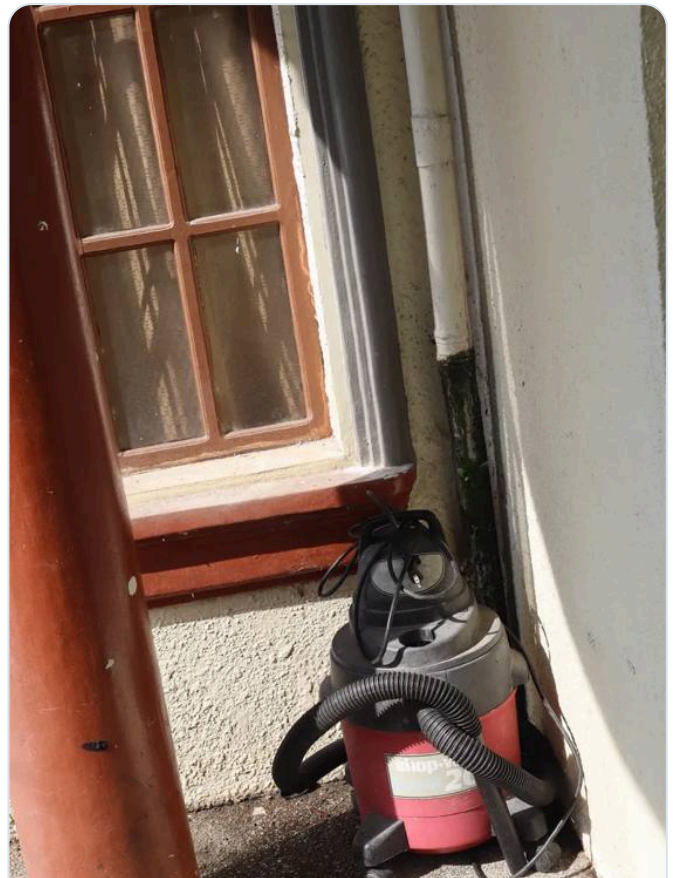
**PHOTO 14 · SIDE WALL**

Side wall with window, downspout pipe and stored equipment beside the porch column.

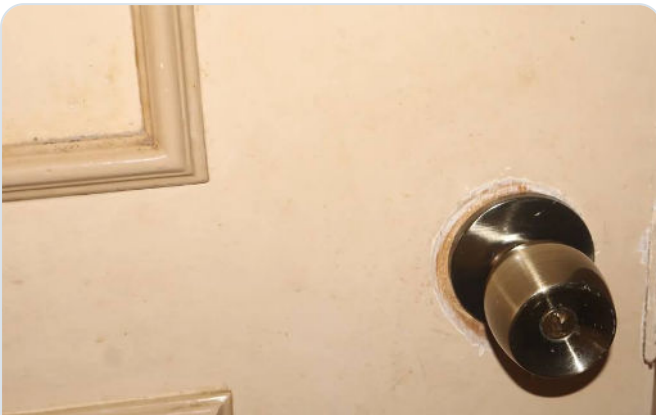
**PHOTO 16 · INTERIOR DOOR**

Interior panel door and brass knob; wear and marks around the lockset.
